DETERMINING REASONS FOR HEAD GASKET FAILURES IN AIR-COOLED ENGINES WITH A SIMPLE TESTING METHODOLOGY

BY MARK KINCART AND JEFFREY STARK

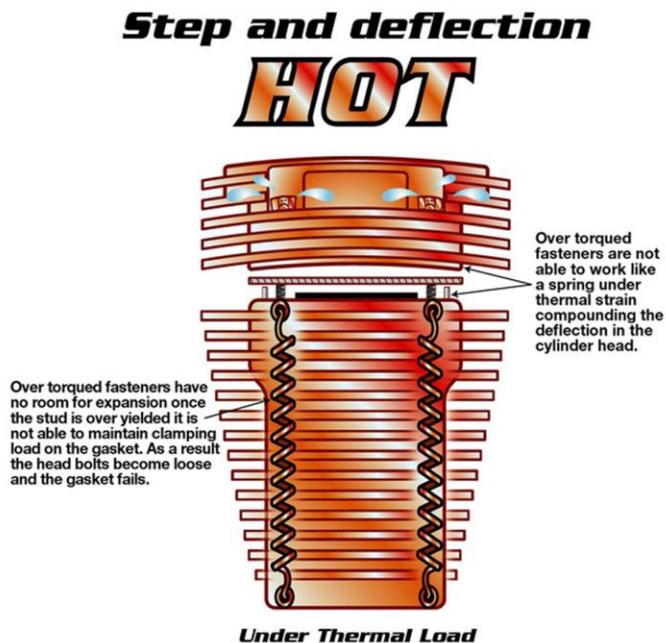
Figure 1 – An illustration of what can happen with step and deflection when there is too much tension on the fasteners, not allowing for proper thermal expansion of the gasket.

or a few months. Several heat cycles (i.e. thermal expansions of the cylinder head), and things start to settle. All that distortion and stress need to go “somewhere”. (See Fig. 1 for an “illustration” of thermal expansion problems experienced by an over torque of a head gasket.) So, one head bolt begins to loosen; then another. Some blow-by now occurs, but only for a few minutes and then it goes away. But during the time of that blow-by, the head gasket is beating itself up on the jug and the head like a jackhammer. Now, understand, most bikes are way too loud for riders to hear that tell-tale hiss of the blow-by until it is too late. The head bolts totally lose their clamping force and a blown head gasket results. Even more disturbing, the motor is most likely cold when this happens. But, there’s more: The deflection occurring under thermal load has caused valve guide wear and possibly valve seat damage. Our rider goes to start his bike one day and now wonders why it won’t run properly or won’t run at all. He takes it back to the shop, saying; “I did not hear a thing; I have no idea how the head gasket blew.”

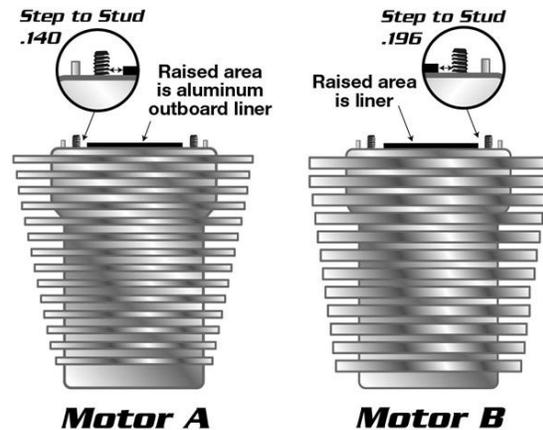
This might be humorous, but the underlying condition is quite serious. The testing process of head gasket assemblies on two different motors (A and B) revealed some very interesting differences. One might say that, from the outside, most motorcycle engines look the same: air-cooled V-Twins. On Motor A we found the cooling fins to be much thinner and more of them than on Motor B, which has very heavy cooling fins. Other differences were: Motor A uses a lead-in on the jug for the head bolts. The step in the jug on Motor B is the liner only. The distance of the step on Motor A is greater than that on Motor B. The bottom of the stud on Motor B is at a 90 degree angle, creating a potential problem area. Conversations with another colleague revealed that Company A producing Motor A claimed a 1.27 mm growth between the fins at 121.1 degrees C. Company B, with its motor, claimed around 2.03 mm growth at 121.1 degrees C. Between the two motors we also discovered the step to stud ratio to be a factor. On Motor A the step extends to within 3.56 mm of the stud; on Motor B it extends to within 4.98 mm of the stud. This appears to compound the leverage the head bolt introduces. (See Fig. 2.)

The step to stud clearance compounds the leverage on the cylinder head. May cause miss alignment of the dowel pins on first torque sequence producing improper head seating.

Figure 2 --Shown is the crucial "Step to Stud" ratio. Problems can occur when head bolt leverage is not taken into account when trying to properly install and torque a head gasket.

states the step is not needed. In fact, deflection can occur with just 2.07 kg-f m of torque due to the step and starting torque value. Deflection and the level of deflection clearly will depend on whose motor is being worked on. We used Motor B using the torque sequence and values as suggested by the manufacturer. (See Fig. 2 for a step to stud issue illustration.)

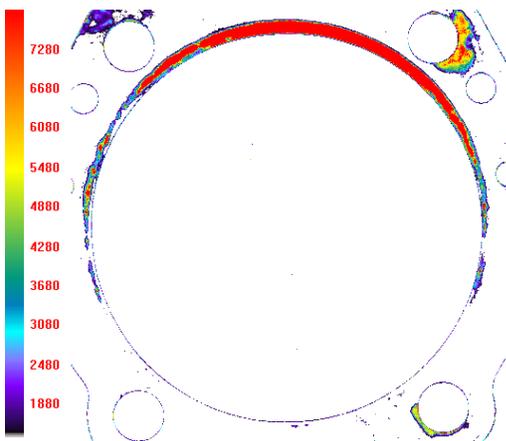
Figure 3 – Shown is the result of torque at 2.07 kg-f m meter N pattern, driver standard, only two bolts, rear cylinder, TPSF Medium. The kg/cm² range shown here is >500 kg/cm² with torque on only two heat bolts. A second test with torque on all four head bolts at the same conditions not only revealed >500 kg/cm² but also significant and observable distortion in the “gasket”.

For the first test, we used Film Medium (100 - 500 kg/cm²) with a time of three minutes; N torque pattern starting on the drive side oil return port. First torque value was 2.07 kg-f m; the final torque value was 2.07 kg-f m. After installing the film and head gasket, the head was placed on the cylinder and all four head bolts were snugged using an N pattern. Torque to 2.07 kg-f m was then applied to two of the head bolts. After waiting three minutes, the head was removed. As seen in Fig. 3, the film’s 500 kg/cm² limit was exceeded with just 2.07 kg-f

m. Using another piece of film, another test was performed, using the same N pattern sequence but all four head bolts received torque to 2.07 kg-f m. We waited three minutes; then pulled the cylinder head. The film’s maximum range again was exceeded, but this time there was also observable distortion. As can be seen, one side of the gasket is now wider than the other; a gap has also occurred in the oil return area. We feel this occurred due to: 1. First torque value is too high; 2. The step to stud distance relationship compounds the leverage; 3. There is now an additional issue of proper seating of the head on the jug as the deflection can cause the two small dowel pins to cock in the head, preventing proper seating. (End result of this is some loading on fire ring due to step; this clearly indicates uneven loading on balance of the head means false torque.) As can be clearly seen, the first stage of head

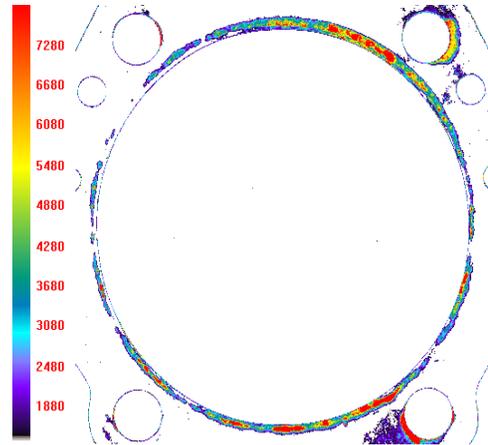
For our second series of tests, we used Film Medium again; timed three minutes, N pattern starting on the drive side oil return port. Different this time from the earlier test was an initial and final torque value of only 0.69 kg-f m. New film and a new head gasket was installed; all four head bolts were installed with torque to 0.69 kg-f m. After waiting the three minutes and removing the film, we discovered that, with just 0.69 kg-f m of torque, over 175.77 kg/cm² was generated. Also, we noticed a more uniform seal on the fire ring as shown in Fig. 4. This information backed up our thesis of the first torque value being crucial to proper head seating. Jumping to a higher

Figure 4 – With only 0.6912748 kilogram-force meter N pattern torque, not only was there a more uniform seal on the fire ring, but the maximum kg/cm² range was >175.77 kg/cm²; this was much better than the earlier >500 kg/cm² at 2.07 kg-f m N pattern torque.

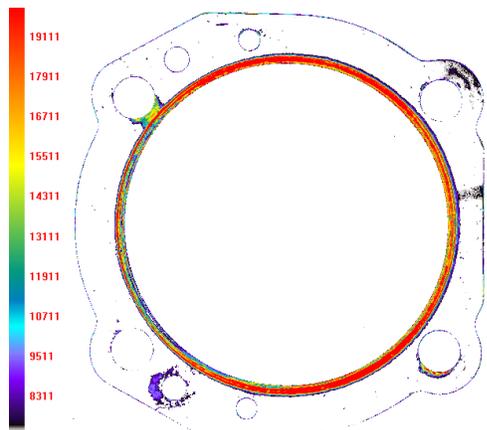
torque on the second or third cycle can still cause deflection due to the dowels. Therefore, some caution still needs to be exercised here. Our main concern with the step lies in our observation of no support for the head past the fire ring (see Fig. 5). As the engine itself heats up, added stress is placed on the studs and the cylinder head. This also transfers, we believe, to the jug. Having the cylinder head half the thickness on one side as opposed to the other is also a concern. Clamping force on the gasket

Figure 5 – While there is more uniform sealing (as shown below), there is also concern about possible improper sealing on the left side of the gasket. This could indicate deflection due to the dowels and indicate a lack of support for the head past the fire ring.

is very uneven due to the step on the cylinder.

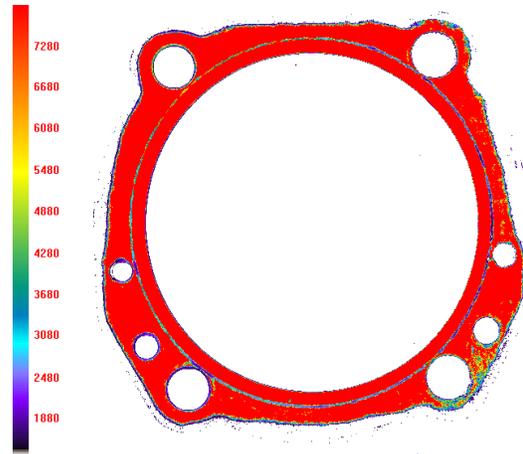
At 4.56 kg-f m, we determined that over 2,765.1 kg-f m of clamping force was generated (down to 0 kg/cm²) outside of the fire ring, depending on the density of the gasket. (See Fig. 6.) This information was gathered using a modified low density gasket and a standard supplier gasket using the supplier’s torque specifications, plus an “X” pattern gasket at 4.562 kg-f m. We decided to conduct some further testing to determine the best possible clamping values. As can be seen from Figures 7 and 8, we used Film Medium to perform an additional test with a standard gasket at 6.22 kg-f m torque. This clearly revealed no apparent change in clamping force, suggesting to us that maximum clamping force is achieved at 4.56 kg-f m or less.

Figure 6 – In this particular test, we discovered that, at 4.56 kg-f m, over 2,765.1 kg-f m of clamping force was generated outside of the fire ring, depending on the density of the head gasket.

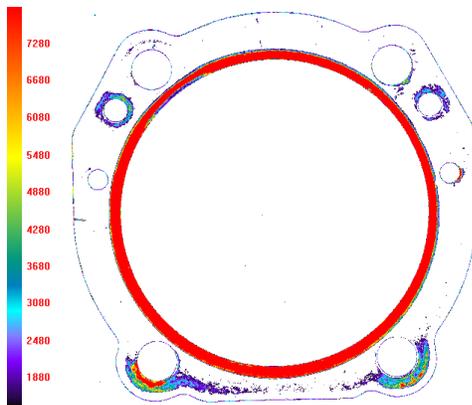
(Fig. 7)

Figures 7 and 8 – In these Figures (Fig. 7, left, and Fig. 8, right), a control test at 6.22 kg-f m torque revealed no apparent change in clamping force. This suggested to us that maximum clamping force on head gaskets of air-cooled engines is achieved at 4.57 kg-f m or less.

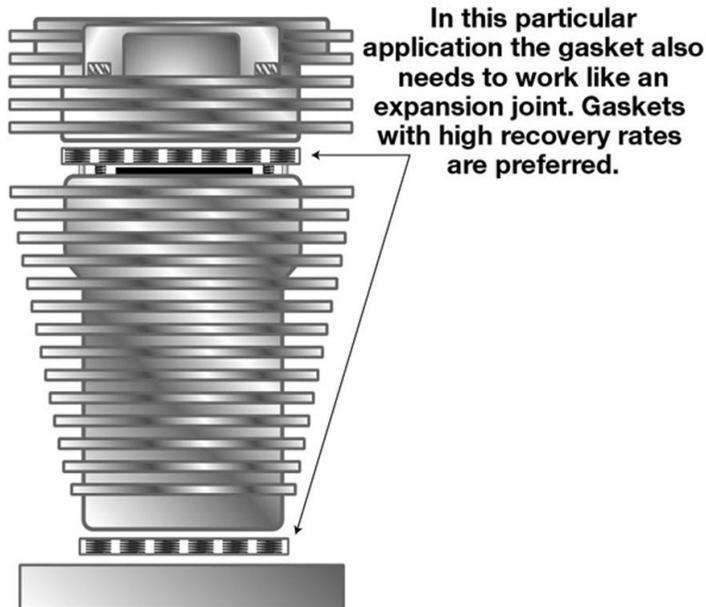
Figure 9 – Clearly seen here is the need for the head gasket(s) to provide room for expansion in the cylinder due to thermal growth. Lower torque values and lower yield values seem to allow for better thermal expansion.

with the lower torque values. (See Figure 9 for the gasket's important role in acting as an expansion joint.)

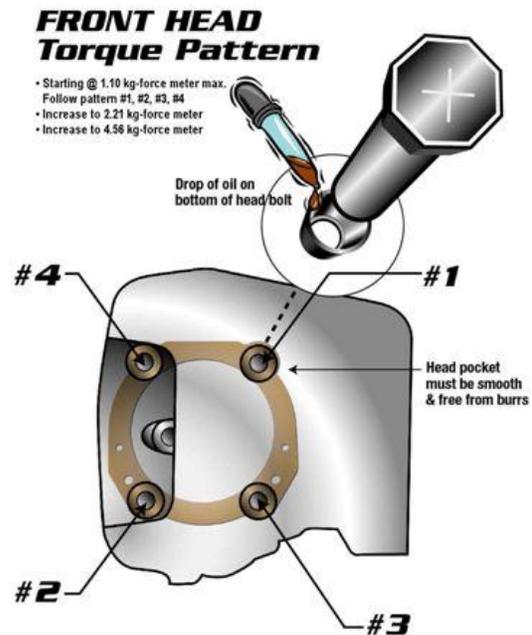
Figure 10 – In our opinion, the use of proper fasteners and a proper torque pattern will be very beneficial to avoiding head gasket failures in air-cooled engines.

At this time, without extensive re-design of the cylinder head and the step/stud ratio, we feel the fix can be simple. Quality studs and head bolts installed properly with a quality thread lubricant will be the first step in a successful build. Making sure no burrs or scars exist in the head pocket or on the underside of the head bolt along with properly fitted dowel pins will insure a successful seal.

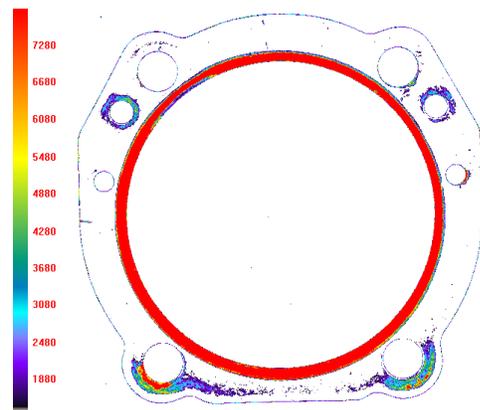
(Fig. 7)

Figures 7 and 8 – In these Figures (Fig. 7, left, and Fig. 8, right), a control test at 6.22 kg-f m torque revealed no apparent change in clamping force. This suggested to us that maximum clamping force on head gaskets of air-cooled engines is achieved at 4.57 kg-f m or less.

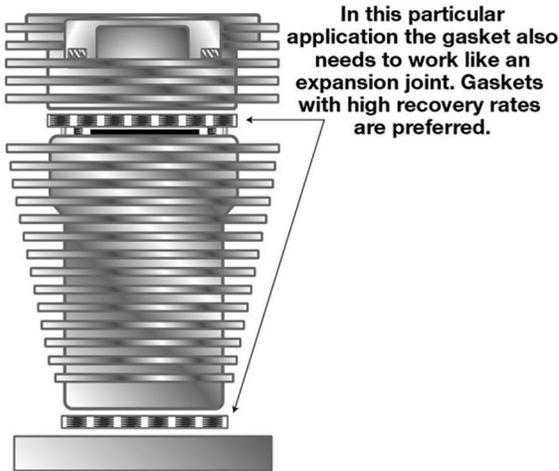
(Left) Figure 9 – Clearly seen here is the need for the head gasket(s) to provide room for expansion in the cylinder due to thermal growth. Lower torque values and lower yield values seem to allow for better thermal expansion.

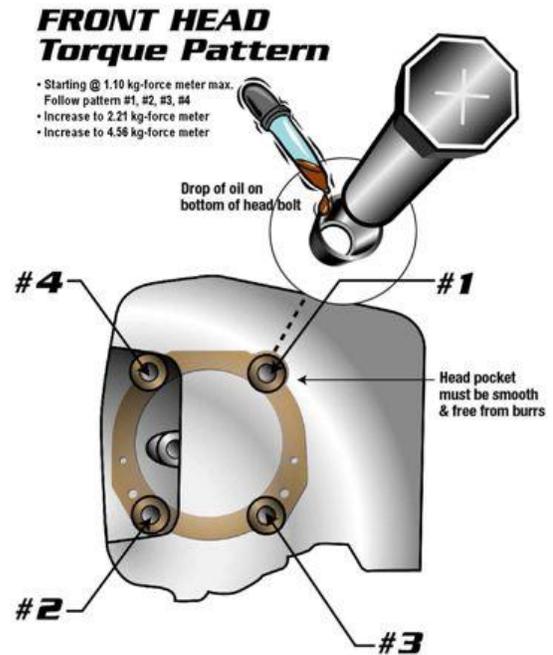
(Right) Figure 10 – In our opinion, the use of proper fasteners and a proper torque pattern will be very beneficial to avoiding head gasket failures in air-cooled engines.
