DESIGN OF A SHAKER-CLAMP SYSTEM FOR INERTIAL SHAKERS OF COFFEE TREES

Federico García Uribe¹;
Carlos Eugenio Oliveros Tascón²

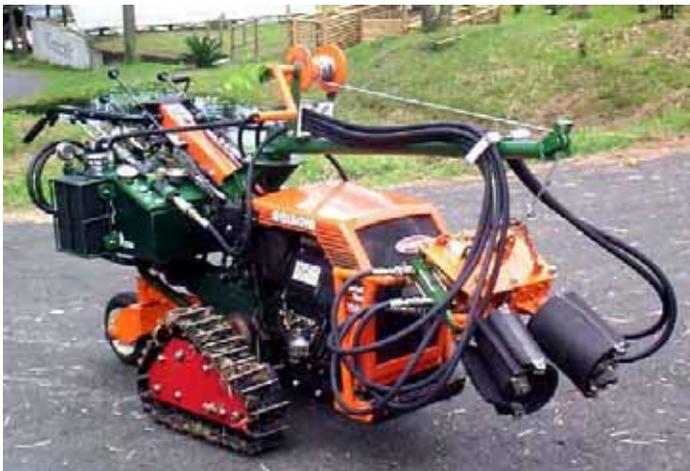
Figure 2 -- Trunk shaker with multidirectional pattern for coffee trunks (VITAC-1) developed at CENICAFE (2001). (Picture source García, 2001)

The equipment used to evaluate the shaker-clamp system was a trunk shaker operated by a hand tractor (10 kW) developed at CENICAFE, called VITAC-1 (Figure 2). The shaker was operated at the following conditions: clamping pressure 9992.18 kPa (1450 psi), shaking frequency 1500 cpm, eccentricity of the unbalanced masses 56.4 mm, shaking pattern of 10 loops (speed ratio of 7:3), clamping point of the shaker in the trunk 40 cm over the ground, during 10 seconds.

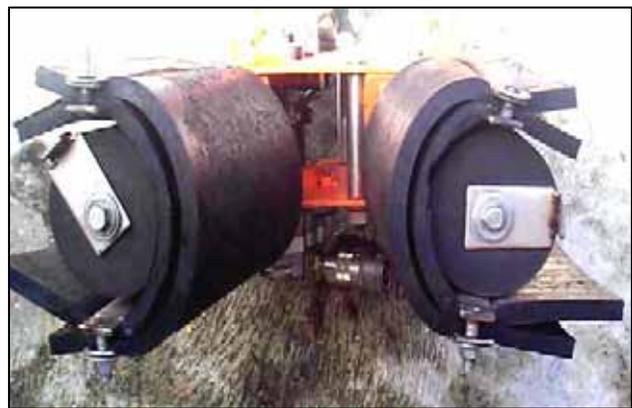
Figure 3 -- General view of the shaker-clamp system designed for the trunk shaker "VITAC-1" (Picture source García, 2001)

The shaker-clamp system was designed with two elements: a movable body, operated by means of a hydraulic cylinder, and a second fixed body, welded to the structure of the shaker. Each element was made up of

a cylinder of rubber of hardness 55° Shore A, of 100 mm of diameter and 200 mm in length assembled on a calibrated steel axis 1020 of 25.4 mm of diameter. On each rubber roller, a pair of bands or aprons elaborated in foamy rubber of hardness 30° Shore A reinforced with canvas ribbing of 350 mm in length, 220 mm wide and 10 mm of thickness, were placed. The aprons of the mentioned material were used for the reduction of damages in the bark of the coffee plant at the subjection zone produced by the tangential stresses generated during the vibration. The function of the rubber rollers is to transmit the loads generated in radial sense.

During manufacture of the shaker-clamp system, the gap between the cylindrical pads of rubber was adjusted to 5,0cm, allowing for extensions if necessary. Sufficient contact area between the foamy rubber aprons and the trunks of the coffee trees were sought with acceptable distance to diminish high stress level zones.

In Figure 3 is shown the shaker-clamp system designed for coffee trees.
