DETERMINING REASONS FOR HEAD GASKET FAILURES IN AIR-COOLED ENGINES WITH A SIMPLE TESTING METHODOLOGY

BY MARK KINCART AND JEFFREY STARK

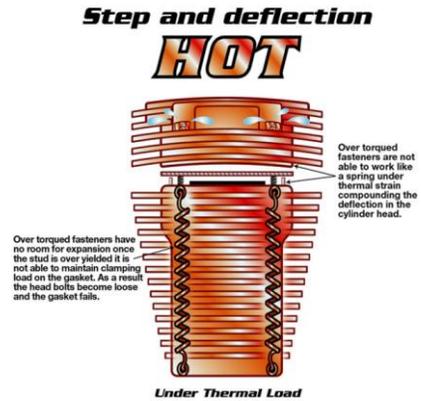
(Right) Figure 1 – An illustration of what can happen with step and deflection when there is too much tension on the fasteners, not allowing for proper thermal expansion of the gasket.

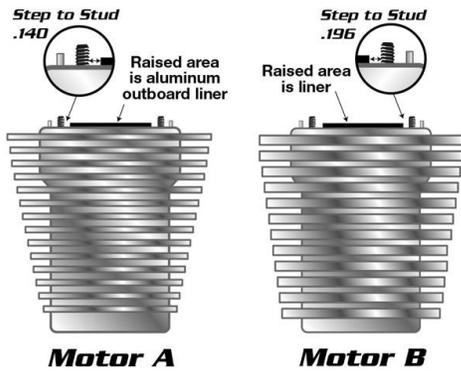
Figure 2 --Shown is the crucial "Step to Stud" ratio. Problems can occur when head bolt leverage is not taken into account when trying to properly install and torque a head gasket.

states the step is not needed. In fact, deflection can occur with just 2.07 kg-f m of torque due to the step and starting torque value. Deflection and the level of deflection clearly will depend on whose motor is being worked on. We used Motor B using the torque sequence and values as suggested by the manufacturer. (See Fig. 2 for a step to stud issue illustration.)

(Left) Figure 2 -- Shown is the crucial “Step to Stud” ratio. Problems can occur when head bolt leverage is not taken into account when trying to properly install and torque a head gasket.

The step to stud clearance compounds the leverage on the cylinder head. May cause miss alignment of the dowel pins on first torque sequence producing improper head seating.

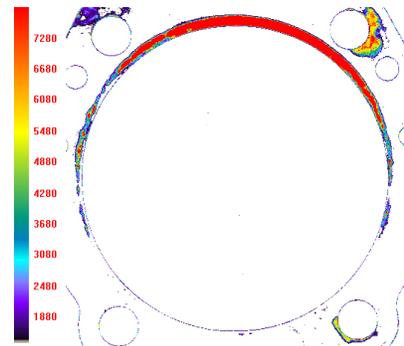
Figure 3 – Shown is the result of torque at 2.07 kg-f m meter N pattern, driver standard, only two bolts, rear cylinder, TPSF Medium. The kg/cm² range shown here is >500 kg/cm² with torque on only two heat bolts. A second test with torque on all four head bolts at the same conditions not only revealed >500 kg/cm² but also significant and observable distortion in the “gasket”.

For the first test, we used Film Medium (100 - 500 kg/cm²) with a time of three minutes; N torque pattern starting on the drive side oil return port. First torque value was 2.07 kg-f m; the final torque value was 2.07 kg-f m. After installing the film and head gasket, the head was placed on the cylinder and all four head bolts were snugged using an N pattern. Torque to 2.07 kg-f m was then applied to two of the head bolts. After waiting three minutes, the head was removed. As seen in Fig. 3, the film’s 500 kg/cm² limit was exceeded with just 2.07 kg-f

(Right) Figure 3 – Shown is the result of torque at 2.07 kg-f m N pattern, driver standard, only two bolts, rear cylinder, TPSF Medium. The kg/cm² range shown here is >500 kg/cm² with torque on only two heat bolts. A second test with torque on all four head bolts at the same conditions not only revealed >500 kg/cm² but also significant and observable distortion in the “gasket”.

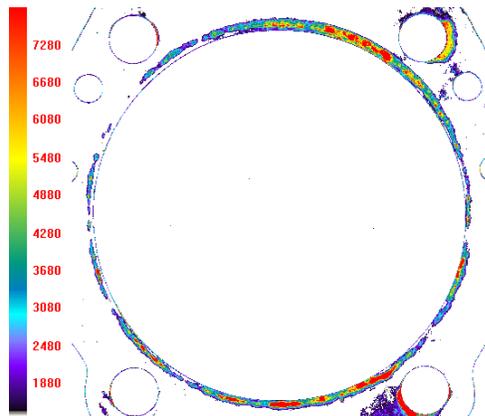
For our second series of tests, we used Film Medium again; timed three minutes, N pattern starting on the drive side oil return port. Different this time from the earlier test was an initial and final torque value of only 0.69 kg-f m. New film and a new head gasket was installed; all four head bolts were installed with torque to 0.69 kg-f m. After waiting the three minutes and removing the film, we discovered that, with just 0.69 kg-f m of torque, over 175.77 kg/cm² was generated. Also, we noticed a more uniform seal on the fire ring as shown in Fig. 4. This information backed up our thesis of the first torque value being crucial to proper head seating. Jumping to a higher

Figure 4 – With only 0.6912748 kilogram-force meter N pattern torque, not only was there a more uniform seal on the fire ring, but the maximum kg/cm² range was >175.77 kg/cm²; this was much better than the earlier >500 kg/cm² at 2.07 kg-f m N pattern torque.

(Left) Figure 4 – With only 0.69 kg-f m N pattern torque, not only was there a more uniform seal on the fire ring, but the maximum kg/cm² range was >175.7673946 kg/cm²; this was much better than the earlier >500 kg/cm² @ 2.07 kg-f m N pattern torque.

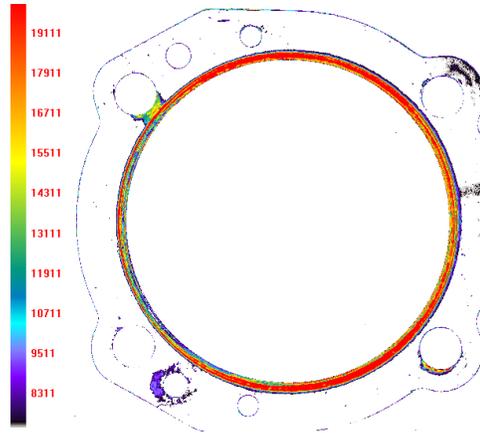
torque on the second or third cycle can still cause deflection due to the dowels. Therefore, some caution still needs to be exercised here. Our main concern with the step lies in our observation of no support for the head past the fire ring (see Fig. 5). As the engine itself heats up, added stress is placed on the studs and the cylinder head. This also transfers, we believe, to the jug. Having the cylinder head half the thickness on one side as opposed to the other is also a concern. Clamping force on the gasket

Figure 5 – While there is more uniform sealing (as shown below), there is also concern about possible improper sealing on the left side of the gasket. This could indicate deflection due to the dowels and indicate a lack of support for the head past the fire ring.

(Right) Figure 5 – As shown in this image, while there is more uniform sealing, there is also concern about possible improper sealing on the left side of the gasket. This could indicate deflection due to the dowels and indicate a lack of support for the head past the fire ring.

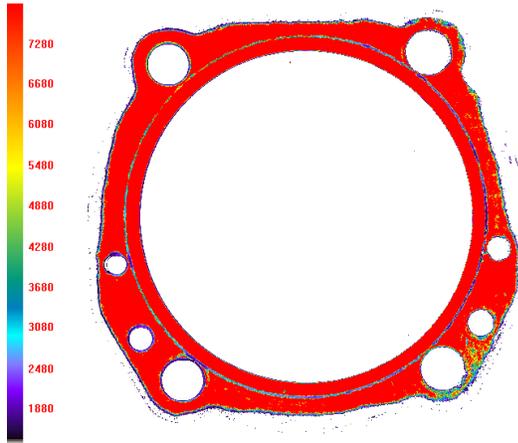
At 4.56 kg-f m, we determined that over 2,765.1 kg-f m of clamping force was generated (down to 0 kg/cm²) outside of the fire ring, depending on the density of the gasket. (See Fig. 6.) This information was gathered using a modified low density gasket and a standard supplier gasket using the supplier’s torque specifications, plus an “X” pattern gasket at 4.562 kg-f m. We decided to conduct some further testing to determine the best possible clamping values. As can be seen from Figures 7 and 8, we used Film Medium to perform an additional test with a standard gasket at 6.22 kg-f m torque. This clearly revealed no apparent change in clamping force, suggesting to us that maximum clamping force is achieved at 4.56 kg-f m or less.

Figure 6 – In this particular test, we discovered that, at 4.56 kg-f m, over 2,765.1 kg-f m of clamping force was generated outside of the fire ring, depending on the density of the head gasket.

(Left) Figure 6 – In this particular test, we discovered that, at 4.57 kg-f m, over 2,765.1 kg-f m of clamping force was generated outside of the fire ring, depending on the density of the head gasket.
