High Contact Pressure Resulting from Bone Marrow Puncture

Hiroshi Fujita^{1*}, Junji Tomiyama², Shigeko Nishimura¹

¹Department of Transfusion Medicine, Tokyo Metropolitan Bokutoh Hospital, Tokyo, Japan; ²Department of Internal Medicine, Tokyo Metropolitan Bokutoh Hospital, Tokyo, Japan.

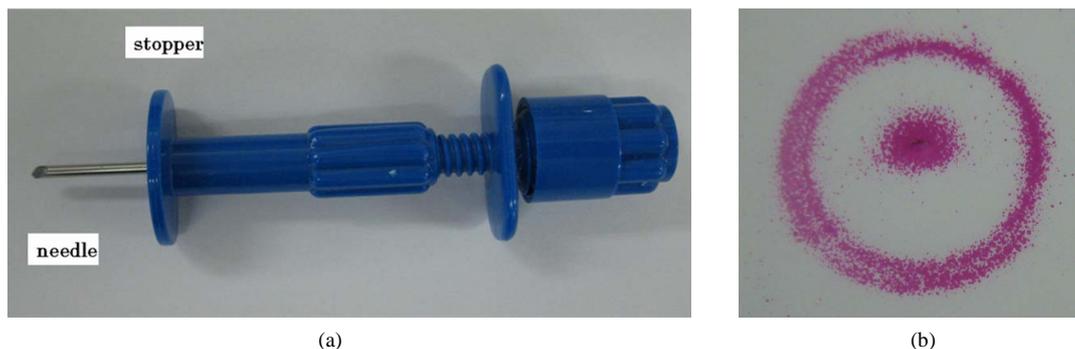
Figure 1. (a) Bone marrow aspiration needle: In this paper, we used two kinds of needles for bone marrow puncture purchased from CareFusion Japan (DIN1518X, 15 G; Tokyo, Japan) and TSK Laboratory (SIL-151, 15 G; Tochigi, Japan). Hematologists (Table 1) performed the bone marrow puncture on wood using a needle purchased from CareFusion Japan, as shown in (a); (b) Pressure sensitive film showing the contact pressure from bone marrow puncture: The Fuji Prescale medium grade pressure-sensitive film with a pressure range of 10 - 50 MPa was used for measuring contact pressure. Hematologist #2 (Table 1) performed the bone marrow puncture on wood using a needle purchased from CareFusion Japan (a). Contact pressure changed the color on the prescale film from the white to pink, or red color dependent on the grade of pressure. Pressure changes were noted at the needle area (center position) and at the stopper area (around the needle area).

We measured the contact pressures of both the needle and stopper areas when hematologists used the bone marrow aspiration needle (CareFusion Japan); the results are shown in **Table 1** and **Figure 1**.

The contact pressure in the needle area at the hip position was 15.2 - 21.4 MPa, which was significantly higher than the contact pressure recorded in the stopper area (7.2 - 11.1 MPa). Similar results were found for the contact pressure at the knee position. As shown in **Table 1**,
